Manhole Inspection Summary

Manhole # S29M__005MH

Insp Date: **12/8/08 11:51 AM**

Location Address: **W.Barre St.**

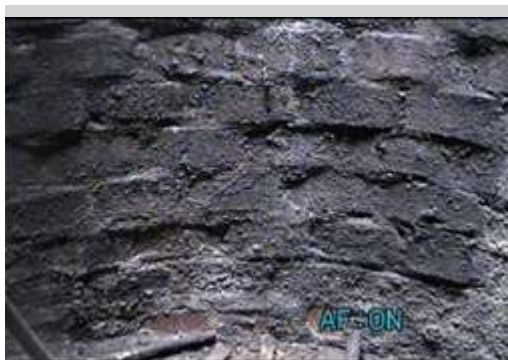
Defect 5

Infiltration: ☐ None ☐ Joint ☐ Cracks ☐ Mortar ☐ Roots ☒ **Wall**

barrel infiltration on wall

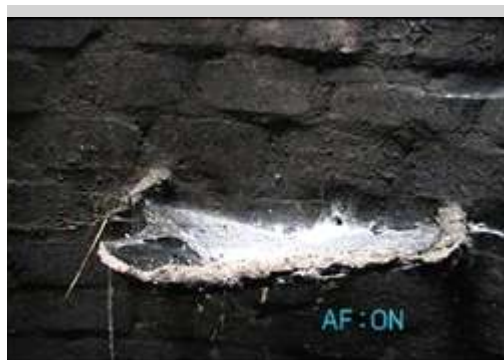
Defect 4

Steps Count: **5** Missing: **0** ☒ **Corroded**

corroded & broken step

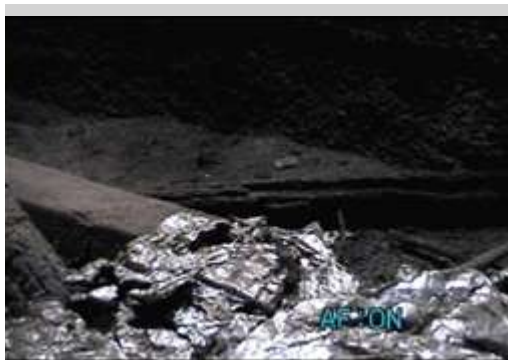
Defect 3

Condition: ☐ Sound ☐ Cracked ☐ Root Intrusion ☐ Deteriorated ☐ Leaks ☒ **Debris**

debris at bottom of manhole

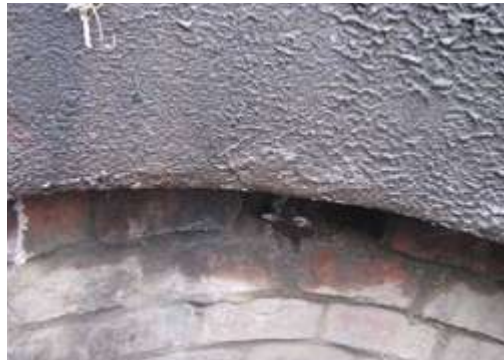
Defect 2

☒ **Leaks**

Condition: ☐ Sound ☐ Cracked ☐ Root Intrusion ☐ Loose Brick ☒ **Deteriorated**

Infiltration: ☐ None ☐ Joint ☐ Cracks ☒ **Mortar** ☐ Roots ☐ Wall

frame infiltration, missing mortar with chimney infiltration

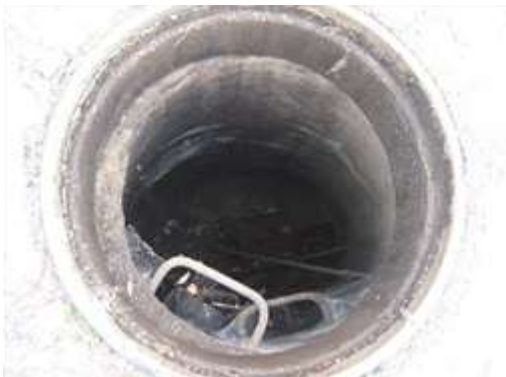
Defect 1

Frame Offset: **3** (in.)

frame offset

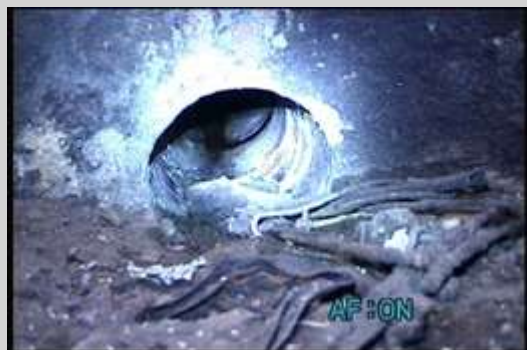
12 O'Clock Outflow

8 in. Circular Gravity Sewer
Pipe Out @ 12 O'Clock

Infiltration: **None** Pipe Seal Cond: **Sound**
